Stress Corrosion Cracking in 316L Stainless Steel Bellows of a Pressure Safety Valve

Bijayani Panda, M. Sujata, M. Madan, S.K. Bhaumik

Council of Scientific and Industrial Research (CSIR), National Aerospace Laboratories,
Materials Science Division, Bangalore 560 017, INDIA

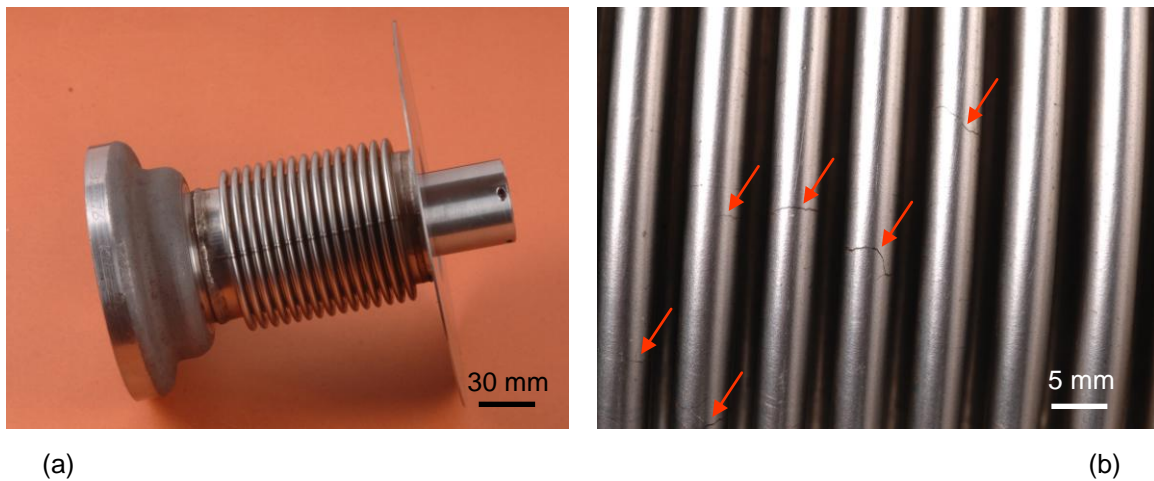
Figure 2(a) shows the photograph of one of the cracked bellows. On observation under stereo-binocular microscope, several cracks were detected

on the external surface of the bellows (Fig.2(b)). The cracks were located on the convolution crest and were oriented along the bellows axis. There were no cracks at the convolution root regions.

Figure 2 (a) Failed bellows, and (b) close-up view showing cracks (arrows) on the convolution crest regions

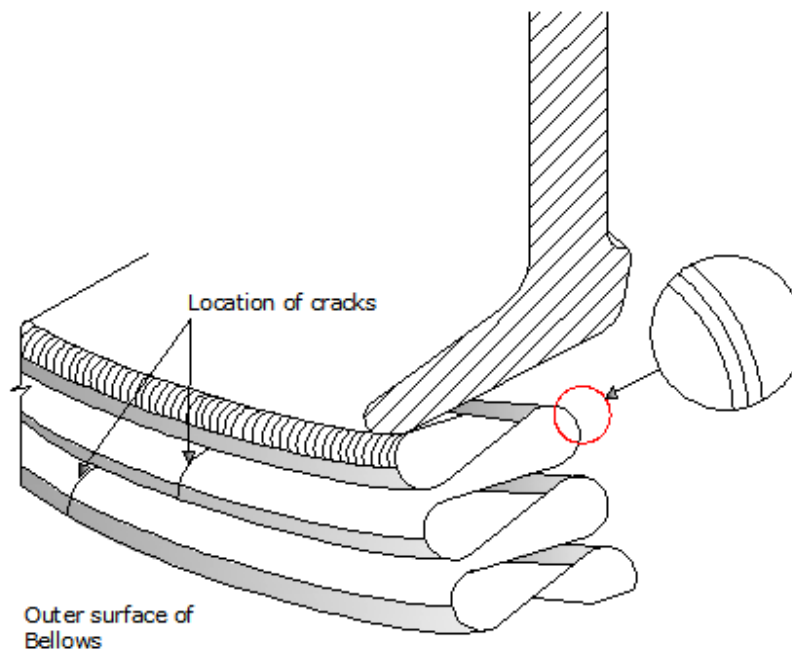
The bellows used in the PSV was of 'S'-type and the construction is shown schematically in Fig.3. The orientation of the cracks on the convolution crest is also shown. In as-received condition, the bellows surface was found to be clean and shiny in appearance. There were no external deposition or corrosion products on the surface. It was learnt that the bellows was cleaned prior to dispatch to the laboratory for investigation.

Figure 3 Schematic diagram showing construction of the bellows and the location of cracks on the bellows surface

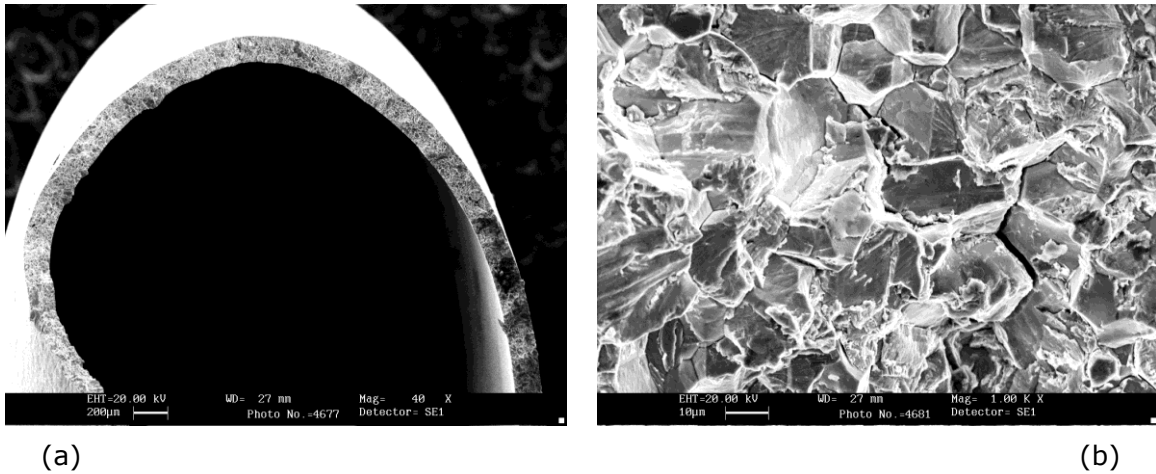
A few cracks were pulled open for scanning electron fractographic study. Figure 4(a) shows an opened surface of one of the cracks on the outer ply of the bellows. It can be seen that the cracking of the bellows had occurred by intergranular mode of crack propagation (Fig.4(b)). Crack surface also showed presence of a number of secondary cracks in a direction perpendicular to the main crack surface.

Figure 4 (a) Secondary electron image of a crack surface, and (b) intergranular mode of crack propagation with secondary cracks at the grain boundaries

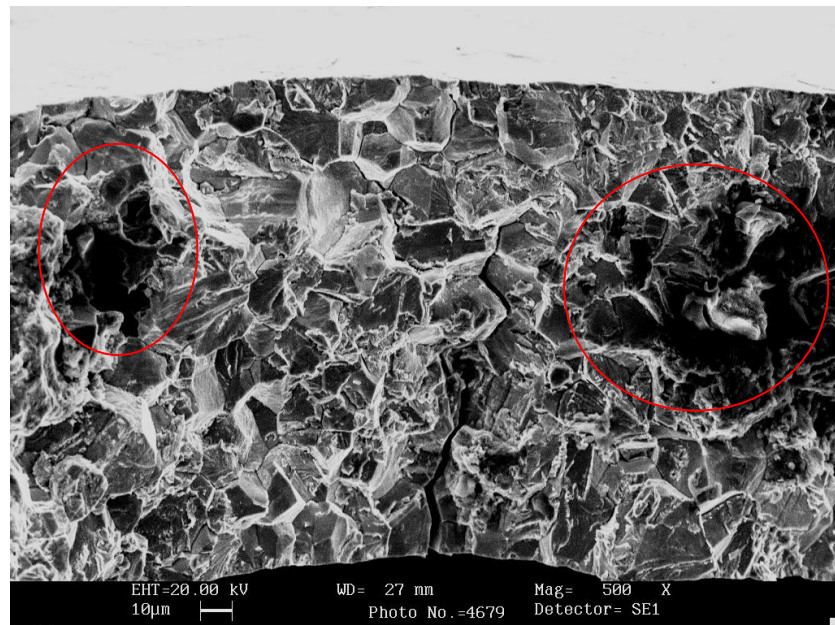
Several locations on the crack surfaces were found covered with firmly adherent corrosion products (Fig.5). In-situ compositional analysis performed by energy dispersive X-ray (EDX) analyzer showed that the corrosion products contained chlorine and oxygen in significant concentrations in addition to the elements of the base material (Fig.6, Table 1). The concentration of chlorine in the corrosion products was determined to be as high as 6 wt.%.

Figure 5 Secondary electron fractograph showing presence of firmly adherent corrosion products on the crack surface (encircled)

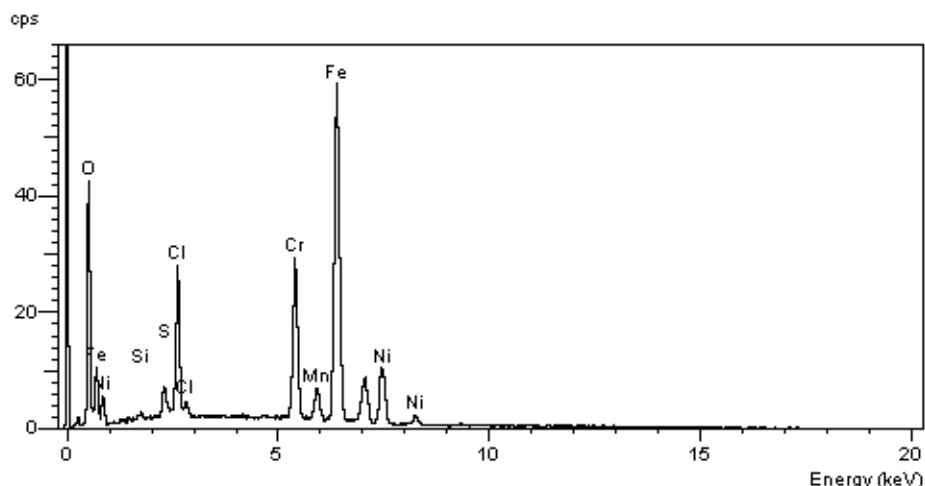
Figure 6 Energy dispersive X-ray spectrum of corrosion products on the fracture surface shown in Fig.5

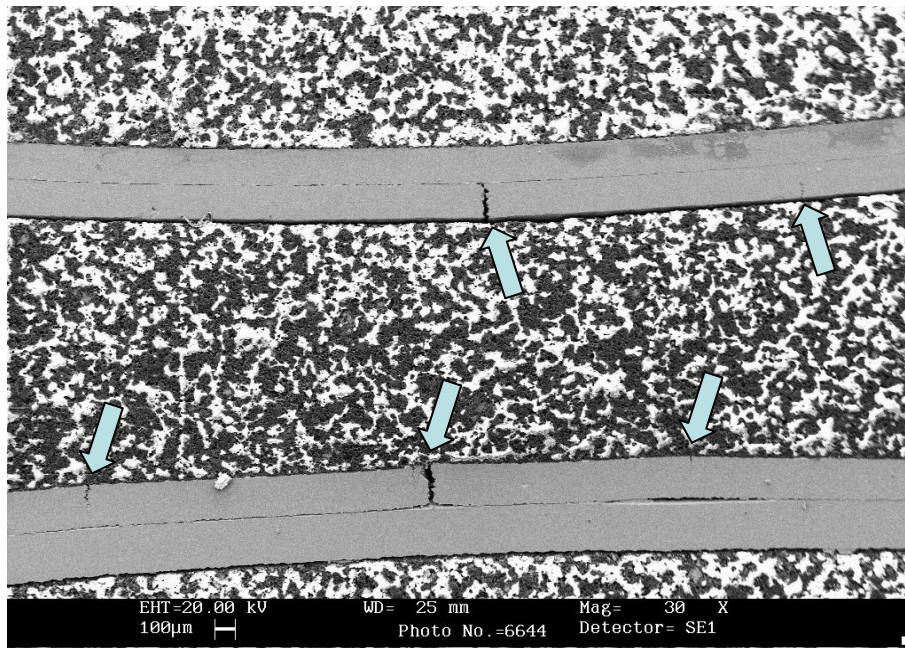
A few samples containing cracks were cut from the plies of the bellows, mounted on the cross section along the transverse direction of the bellows and metallographically prepared. Figure 7 shows the cross section of the plies of the bellows in un-etched condition. A few through and propagating cracks in the outer ply of the bellows can be seen. Figure 8(a) shows a typical propagating branching crack initiating from the outer surface of the bellows. The origin of crack initiation was a tiny region of pitting corrosion on the outer surface. The magnified view of the cracked region is shown in Fig.8(b). Although the branching cracks are predominantly intergranular in nature, transgranular crack propagation can be seen at a few locations.

Figure 7 Secondary electron micrographs of two transverse sections of the bellows showing through cracks (arrows) in the outer ply

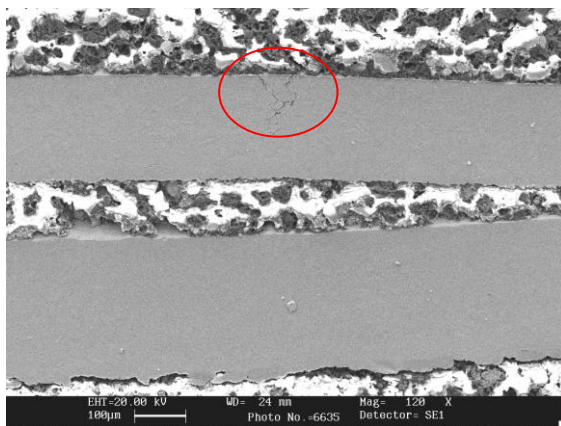
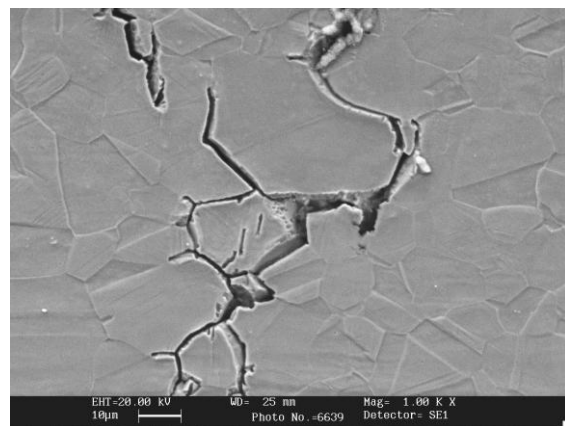
Figure 8 Secondary electron micrographs showing (a) crack initiation region (encircled) on the outer ply of the bellows, and (b) magnified view showing branching cracks

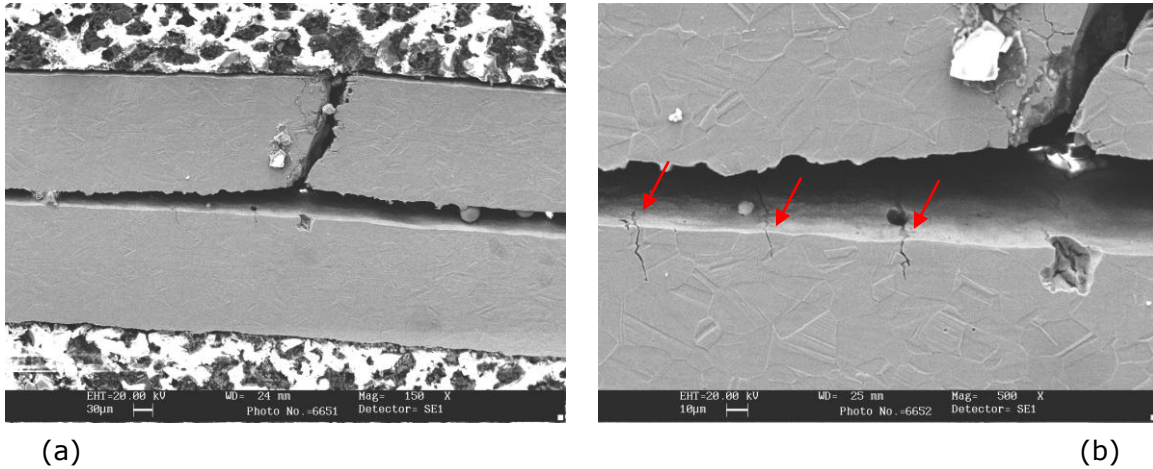
Figure 9(a) shows a secondary electron image of the cross section of the inner ply in the vicinity of a through crack in the outer ply. Magnified view of the region is shown in Fig.9(b). Initiation of a number of cracks on the outer surface of the inner ply can be seen. At a few places, the cracks were found to have propagated through the thickness of both the plies of the bellows (Fig.10).

Figure 9 Secondary electron micrographs showing (a) a through crack in the outer ply of the bellows, and (b) cracks in the inner ply in the vicinity of the through crack in outer ply shown in (a)

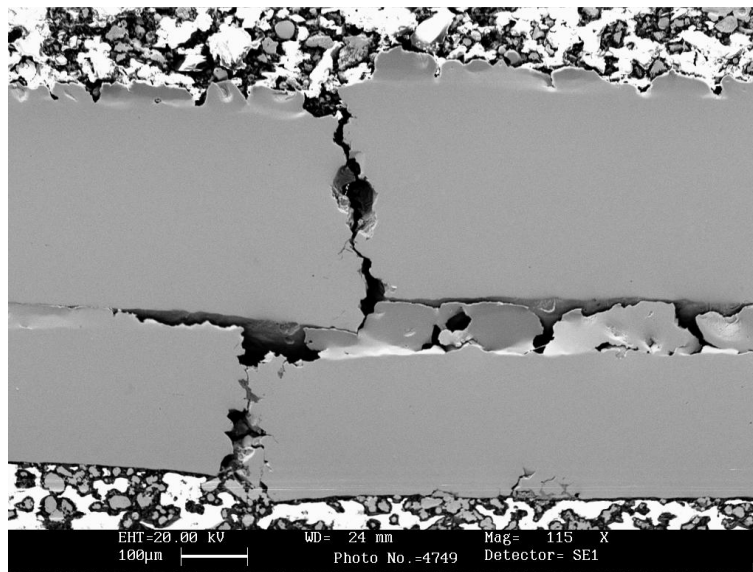
Figure 10 Secondary electron micrograph showing through thickness crack in both the plies of the bellows

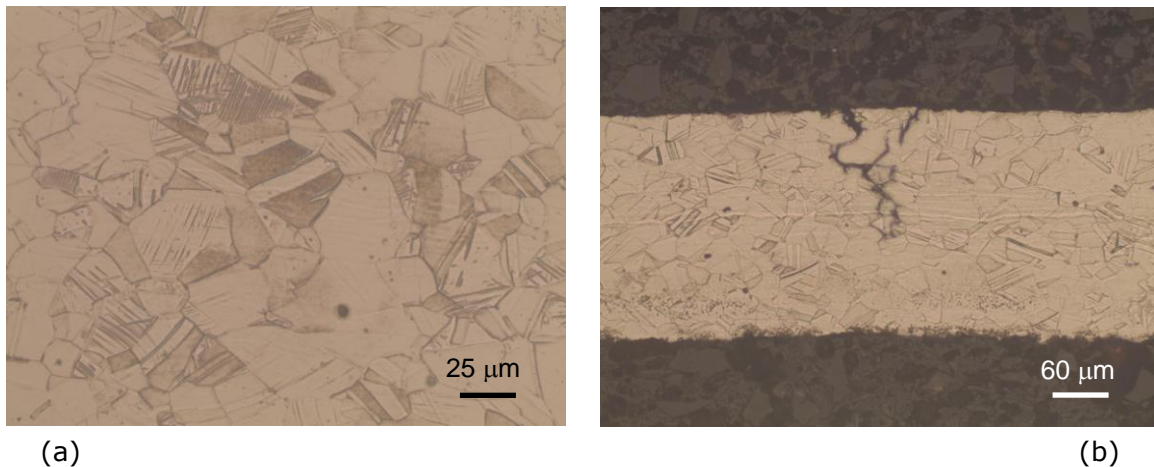
Compositional analysis showed that the bellows was made of 316L grade austenitic stainless steel and it conformed to the design specification (Table 1). The optical microstructures of the bellows material are shown in Fig.11. It consisted of austenite grains. There was no predominance of carbide precipitation at the grain boundaries, eliminating the possibility of sensitization of steel. Study, however, showed extensive formation of shear

bands and deformation twins within the austenite grains (Fig.11(a)). Also, at the central region of the sheet cross section, the microstructure showed presence of stress induced martensite phase (Fig.11(b)).

Figure 11 Optical micrographs showing (a) shear bands and twins within the austenite grains, and (b) stringers of stress induced martensite phase at the mid-section of the sheet

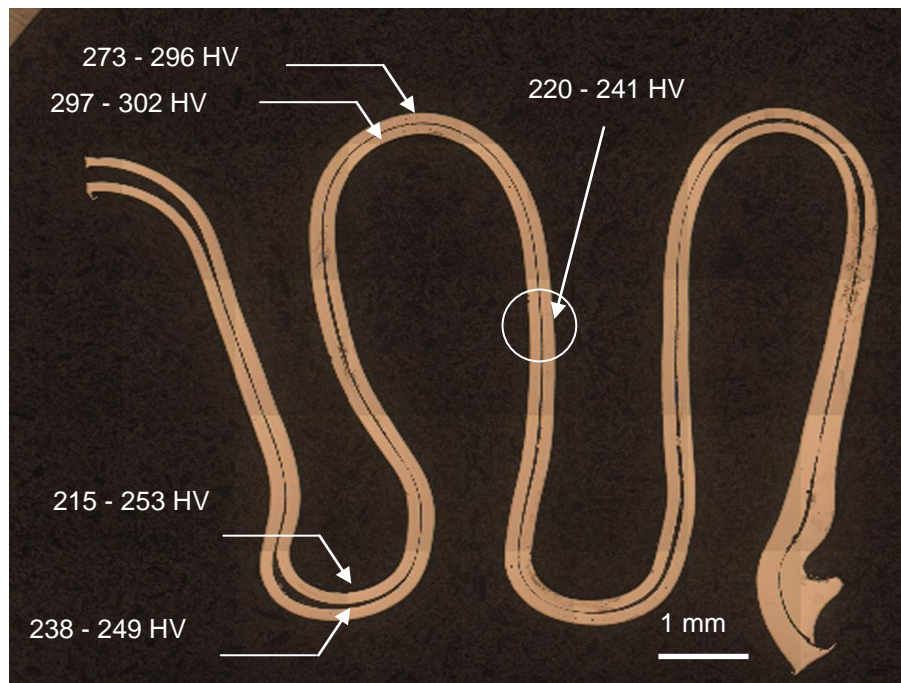
Hardness of the bellows material was determined on longitudinal section of the bellows using Vickers micro-hardness tester at a load of 100 g. The hardness values were found to be in the range 215 to 302 HV, confirming that the bellows was fabricated from cold rolled austenitic stainless steel sheet. Results of the hardness survey, however, showed that average hardness at the convolution crest was significantly higher than that at the convolution root as well as other locations of both the plies of the bellows (Fig.12).

Figure 12 A montage of optical micrographs of the longitudinal section of a part of the bellows; note significantly higher hardness at the convolution crest relative to that at the convolution root

The results of the hardness survey conducted on the failed bellows showed substantially higher hardness at the convolution crest (273-302 HV) compared to that at other regions (215-253 HV). This indicates that probably, the manufacturing method followed resulted in large amount of cold work at the crests compared to elsewhere in the bellows. Since volume fraction of strain induced martensite is a function of amount of cold work, it is, therefore, natural that the martensite formation in the sheet material would be predominant at the convolution crest regions. In presence of corrosive environment, this would facilitate preferential crack initiation at the convolution crest as seen in the present case.

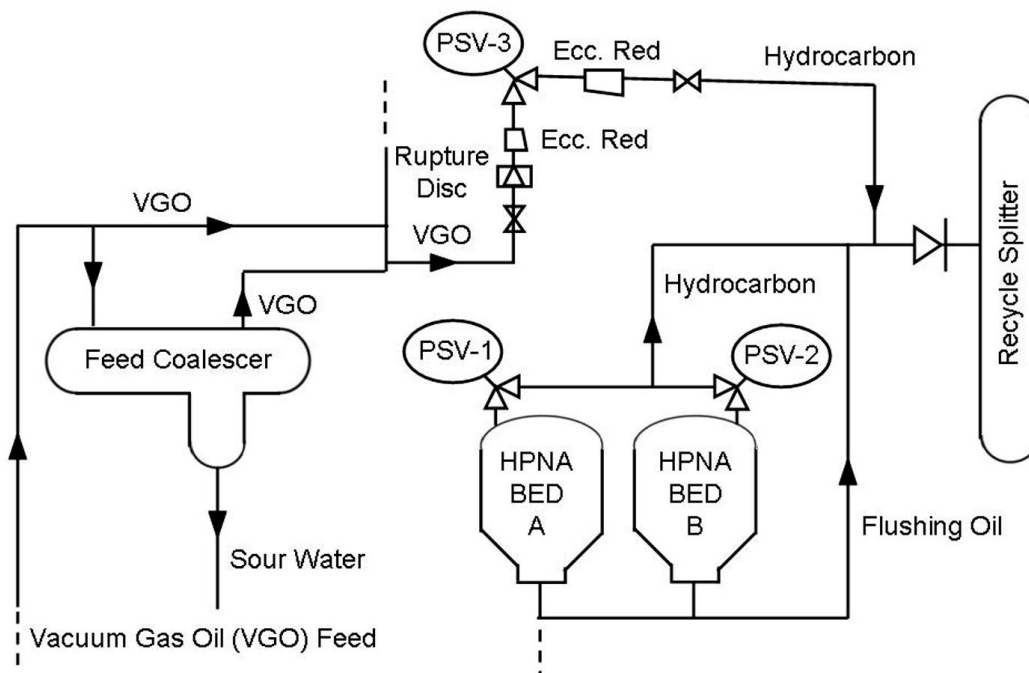
Figure 13 shows the process flow chart and associated equipment in the vicinity of the failed PSV. The PSV is mounted on the feed coalescer which discharges feedstock to the recycle splitter column. In another line and prior to the recycle splitter column, there is a system for removal of heavy polynuclear aromatics (HPNA) from the feedstock. The HPNA system consists

of two beds filled with activated carbon. The HPNAs are adsorbed onto the activated carbon for increasing the downstream hydrocracker catalyst life and avoiding HPNA fouling of feed effluent heat exchangers. The outlet of the HPNA system also joins the splitter column. The outlet pipelines of the HPNA system and the PSV are interconnected. The pressures of both the systems, that is, feed coalescer discharge and the HPNA system are equal.

Figure 12 Schematic showing the process flowchart and the associated equipment in the vicinity of failed PSV-3

The HPNA bed contains granulated activated carbon which is supported by stainless steel screen. It was discovered that there was a failure in the HPNA bed prior to the first failure of the bellows. The failure was in the stainless steel screen. Laboratory tests revealed that this particular batch of activated carbon contained high amount of chlorine and this was responsible for the failure of the stainless steel screen by chloride SCC. The HPNA bed was repaired and the hydrocracker unit was re-commissioned. All the three bellows failures occurred after this incident.

Investigation revealed that subsequent to the failure of the bellows, when the PSV was dismantled for repair, its body was found covered with black deposit. The deposit was formed during the repairing of the HPNA bed and it consisted of activated carbon soot which contained chlorine in high concentration. It was confirmed that this deposit was the source of chloride
